# TISSUE REACTION TO IMPLANTS OF DIFFERENT METALS: A STUDY USING GUIDE WIRES IN CANNULATED SCREWS

D.M. Devine\*, M. Leitner, S.M. Perren, L.P. Boure, and S.G. Pearce

AO Research Institute Davos, Clavadelerstrasse 8, CH-7270 Davos, Switzerland

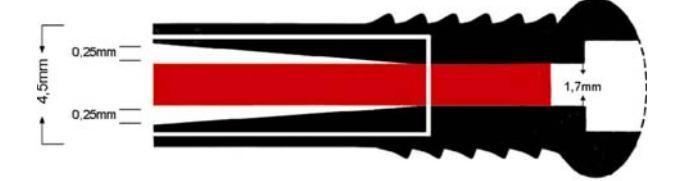
**Figure 1:** The design of the implants to test crevice and/or galvanic corrosion. The implant was designed to replicate situations where an alloy guide wire breaks within a stainless steel cannulated screw. Crevice corrosion was analysed using varying crevice dimensions. No fretting was involved in this model.

Custom-made implants were developed as illustrated in Fig. 1. The overall length of the implant was 24 mm. In all cases the screw was 316L stainless steel while the 1.7 mm diameter guide wire (centre component in Fig. 1) was interchanged between 316L (control), MP35N and L605. In the threaded region, the guide wire was press fit within the screw. A window (indicated by the white lines in Fig. 1) was cut into the cannulated screw from just within the press fit zone to the distal end of the screw. The cannulated part of the screw had a conical shape. This construct was considered to imitate a cannulated screw with a broken guide wire remaining *in situ*, which would simulate a situation of critical crevice and/or galvanic corrosion of dissimilar metals in a mechanically stable condition.

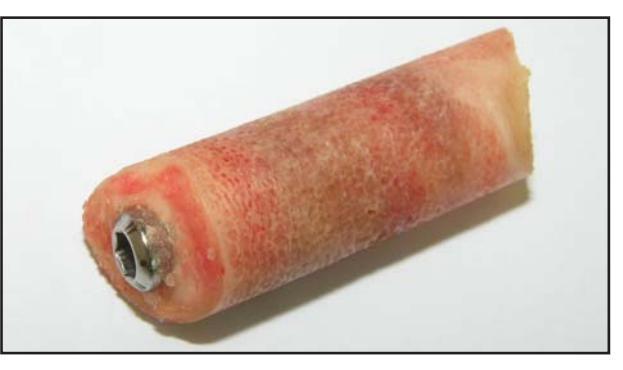
Figure 2: An explanted bone core including the implant.

Post mortem, the devices implanted into the tibia and femurs were cored out in combination with surrounding bone using a custom made coring device, which ensured a bone collar of at least 3 mm around the implant (Fig. 2).

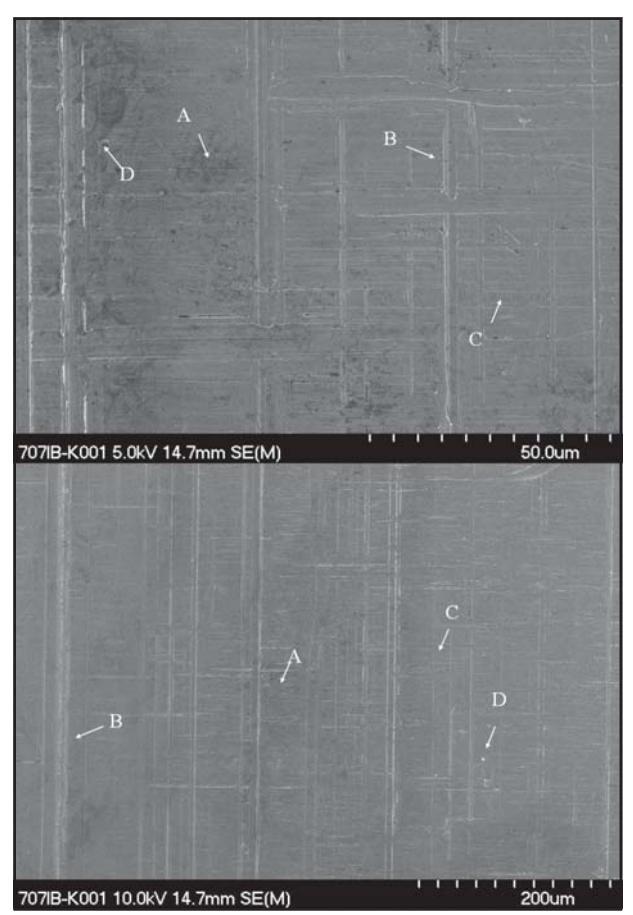
**Figure 3:** Images taken of the same guide wire (316L) after 1 month implantation at position number three using different magnifications. A tissue, B insertion marks, C machining marks, D protrusions.

Evaluation of the explanted screws after cleaning, demonstrated the removal of most of the tissue without the generation of noteworthy artefacts. Remaining tissue artefacts were present on the 316L stainless steel guide wire after one month implantation. It was noted that at an accelerating voltage of 5 kV the dark segments (low density material interrupted as tissue) were more apparent than at 10 kV. This would indicate that a thin layer of tissue was present, as the higher energy electrons easily pass through the low density material. Insertion marks caused by mechanical damage from the manufacturing of the implants were also visible (Fig. 3). Machining artefacts were visible perpendicular to the insertion marks.

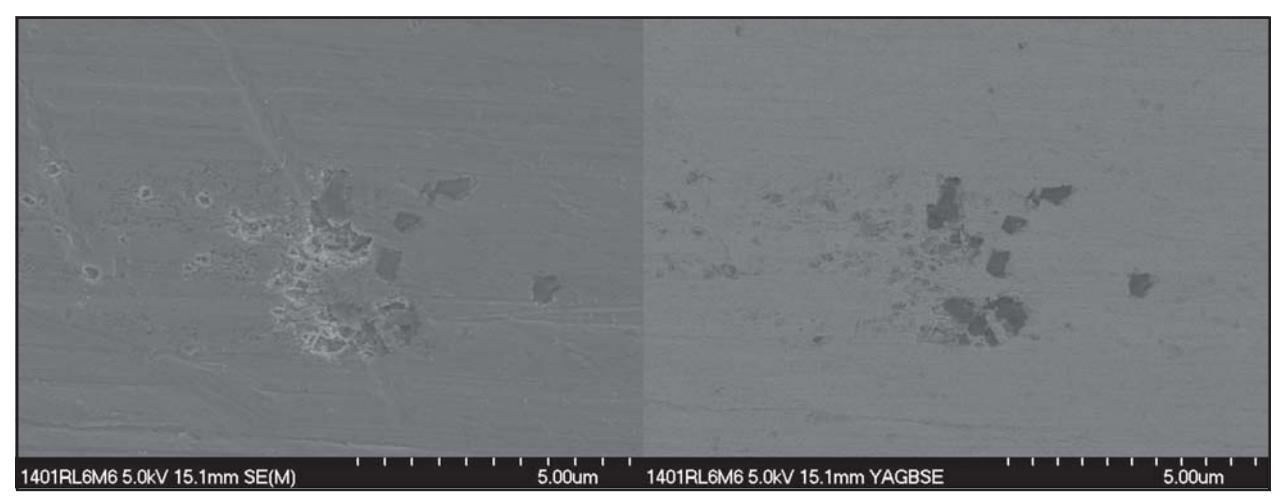
**Figure 4:** L605 after 6 months implantation using secondary electron analysis (left) and back scattered electron analysis (right). After magnification and analysis with BSE, particles suspected of being caused by corrosion were found to be a result of tissue adherence.

After one month implantation, the guide wires consisting of MP35N showed similar surface characteristics to those consisting of 316L stainless steel, with the exception of insertion marks, which were much less evident on MP35N implants. Tissue and protrusions were present to varying degrees on the surface of the guide wires. However, tissue formation was not always as clearly evident and thus secondary electron and back scattered electron images of the same areas were compared to determine if changes in density occurred. This method was used to clarify the presence of tissue. The dark segments visible in BSE indicate that the material had a lower density compared to the metal and it can therefore be concluded that these segments are tissue and not corrosion.

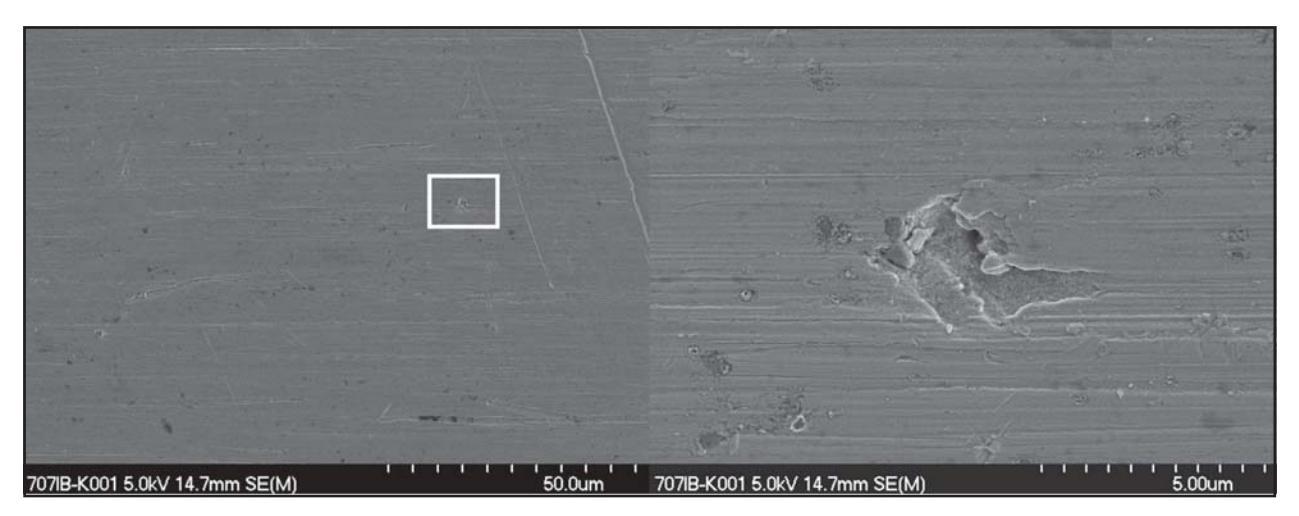
**Figure 5:** L605 after 6 months implantation. In isolated cases, surface defects of undetermined origin were detected. These defects were sporadic and no significant difference was observed between groups.

After six months implantation, the surfaces of the guide wires did not appear to have altered considerably when compared to the one month group. Again artefacts were present on the surface which warranted further investigation for all guide wire types. Some artefacts were suspected of been caused by corrosion. However after further magnification and evaluations with BSE they were determined to be a result of tissue adherence (Fig. 4). Additionally, isolated examples of surface defects of undetermined origin were observed. However, these defects occurred sporadically in all treatments for both time periods and evidence of tissue at the bottom of these defects was common. An example of this is shown in Fig. 5 which occurred in L605 guide wire at position number three.

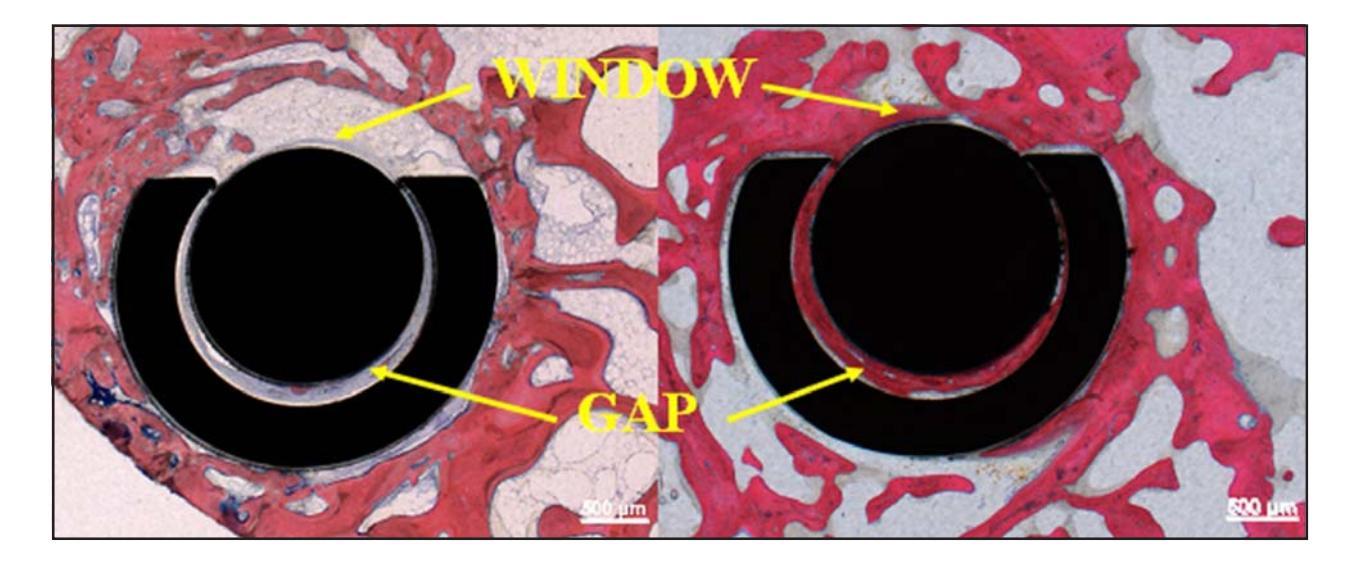
**Figure 6:** a) Section C, 316L stainless steel guide wire after one month implantation showing limited bone re-growth into the drill hole created for placement of the implant; b) ) Section C,, L605 Co-Cr alloy guide wire after 6 month implantation showing bone formation in front of the window and in the gap.

At the six month time-point, remodelling of the drill hole was evident (Figure 6b), and newly formed bone was visible in the region in front of the window. In addition, bone growth into the gap between the guide wire and screw indicated that it was a tolerable environment for new bone formation.

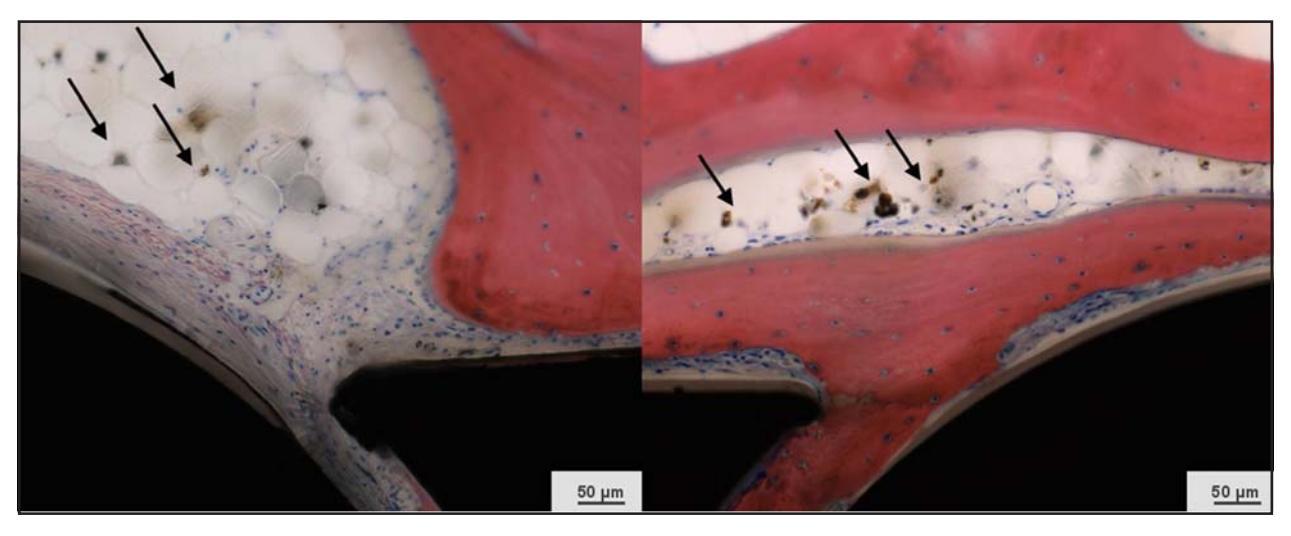
**Figure 7:** Left: Particles present after six months implantation of the L605 guide wire combination, no significant adverse cellular response was observed; Right: Particles (arrows) present after six months implantation of the 316L stainless steel guide wire combination, no significant adverse cellular response was observed.

Particles of opaque material were commonly observed on sections in the six month time period as shown in Fig. 7. These particles, were presumed to be of metallic origin, were not associated with a cellular reaction and no statistical differences in the presence of these particles could be detected between groups. The possibility of these particles being artefacts of sectioning could not be excluded.
